TECHNICAL MEMORANDUM

AN/BQR-7/DT-276

HYDROPHONE FAILURE MODE ANALYSIS

19 January 1968

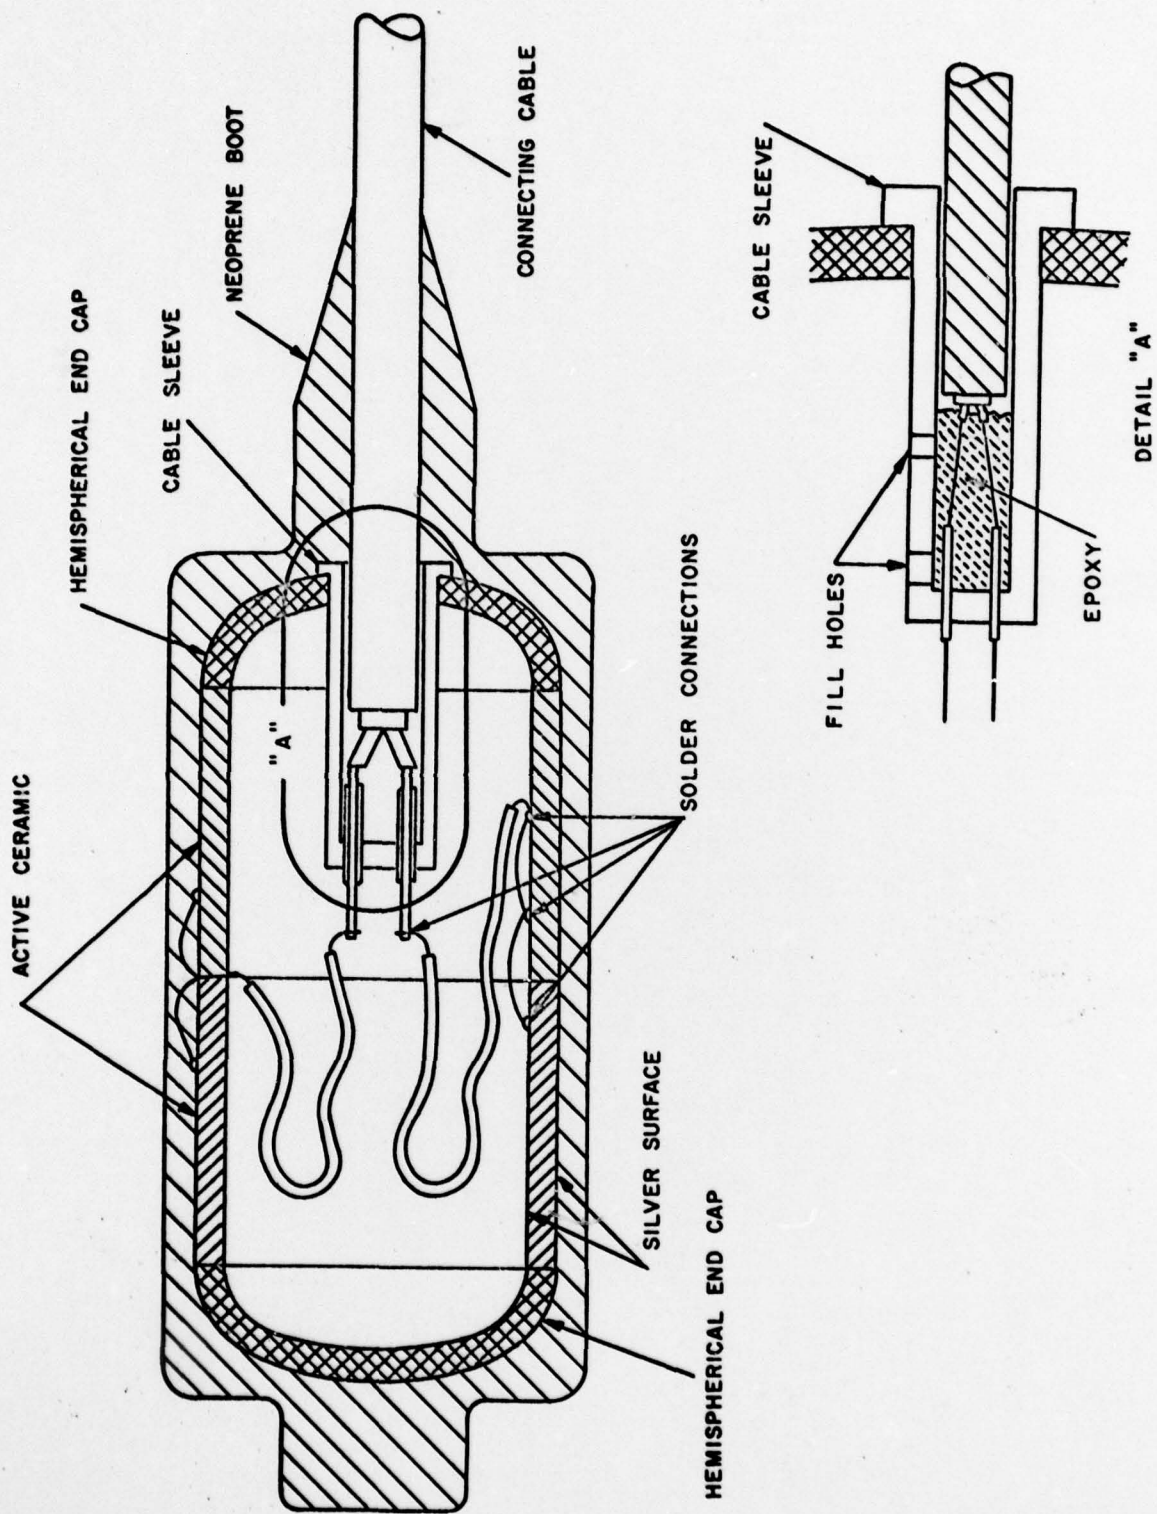
FIG. 1 DT-276/BQR-7 HYDROPHONE

Refer to Fig. 1.

The failure mode associated with most of the hydrophones involved hosing within the cable, into the cable sleeve, and a track along the wall of the sleeve and out of the epoxy filler holes. The detail deficiencies noted do not indicate corresponding deficiencies in the basic mechanical design. The mechanical design of the hydrophone is considered to be very good.
